Tricky recovery

After lying on its back for five months in Peterhead, Scotland, the recovery of Whyte Crane Hires' overturned 500 tonne Liebherr LTM 1500-8.1 All Terrain crane has probably created a good deal of interest. The crane tipped over during the UK's early May bank holiday weekend and remained in that inelegant position all summer, before finally being recovered at the beginning of October. Cranes & Access spoke with Peter Issitt, managing director of Crowland Cranes which was contracted to carry out the recovery, the trickiest he has ever been involved with.

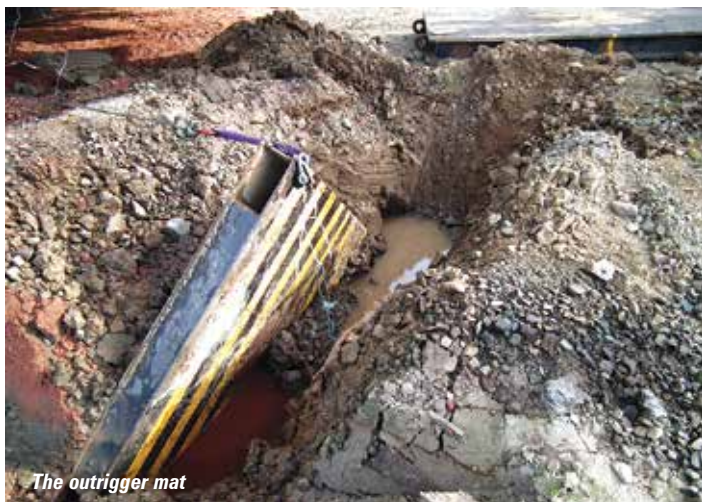
So how did the crane end up in its precarious position? After completing a lift for client Aquatic Subsea - an independent supplier of powered-reel and tensioner systems to the oil and gas sector - at its premises in Peterhead the ground failed under one of the rear mats and the outrigger sank around 2.5

metres through a hardcore base layer into a layer of clay below. All had appeared well with the set-up with the crane sitting on steel mats supplied by the client. However, as the crane tipped the outrigger and mat ended up several metres underground.

The outrigger mat

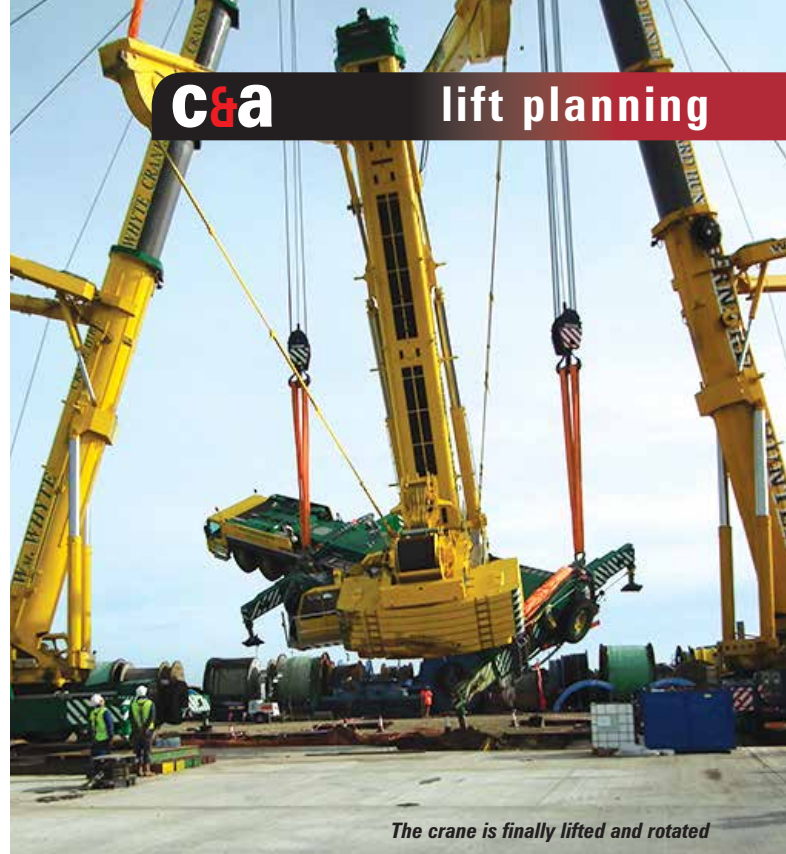
The crane is finally lifted and rotated

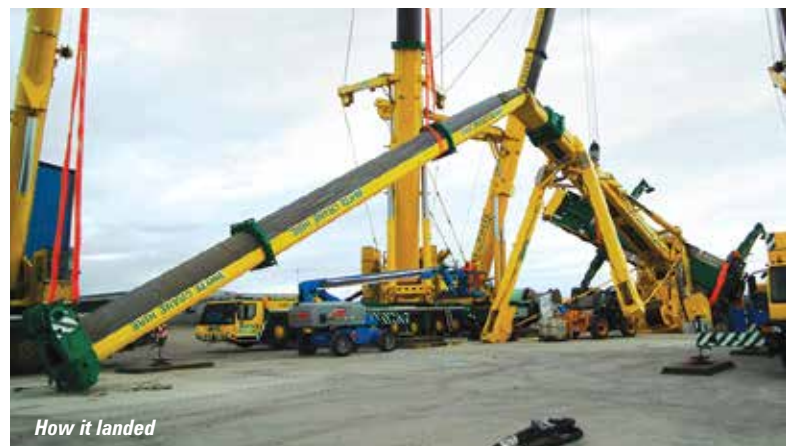
How it landed

The LTM 1500 came to rest with four points in contact with the ground. The chassis - several metres off the ground at its lowest point and inclined at an angle of about 45 degrees with the cab at a height of around 15 metres - was in contact via the sunken outrigger, which had just one section of the beam visible. The rear of the superstructure ballast was also resting on the ground, together with one of the Y-Guy arms with the other was about 1.5 metres off the ground. The impact of the crane

coming to rest caused one section (section four) of the six-section 84 metre main boom to buckle at its base, with the boom nose resting on the concrete (only the last three sections had been extended).

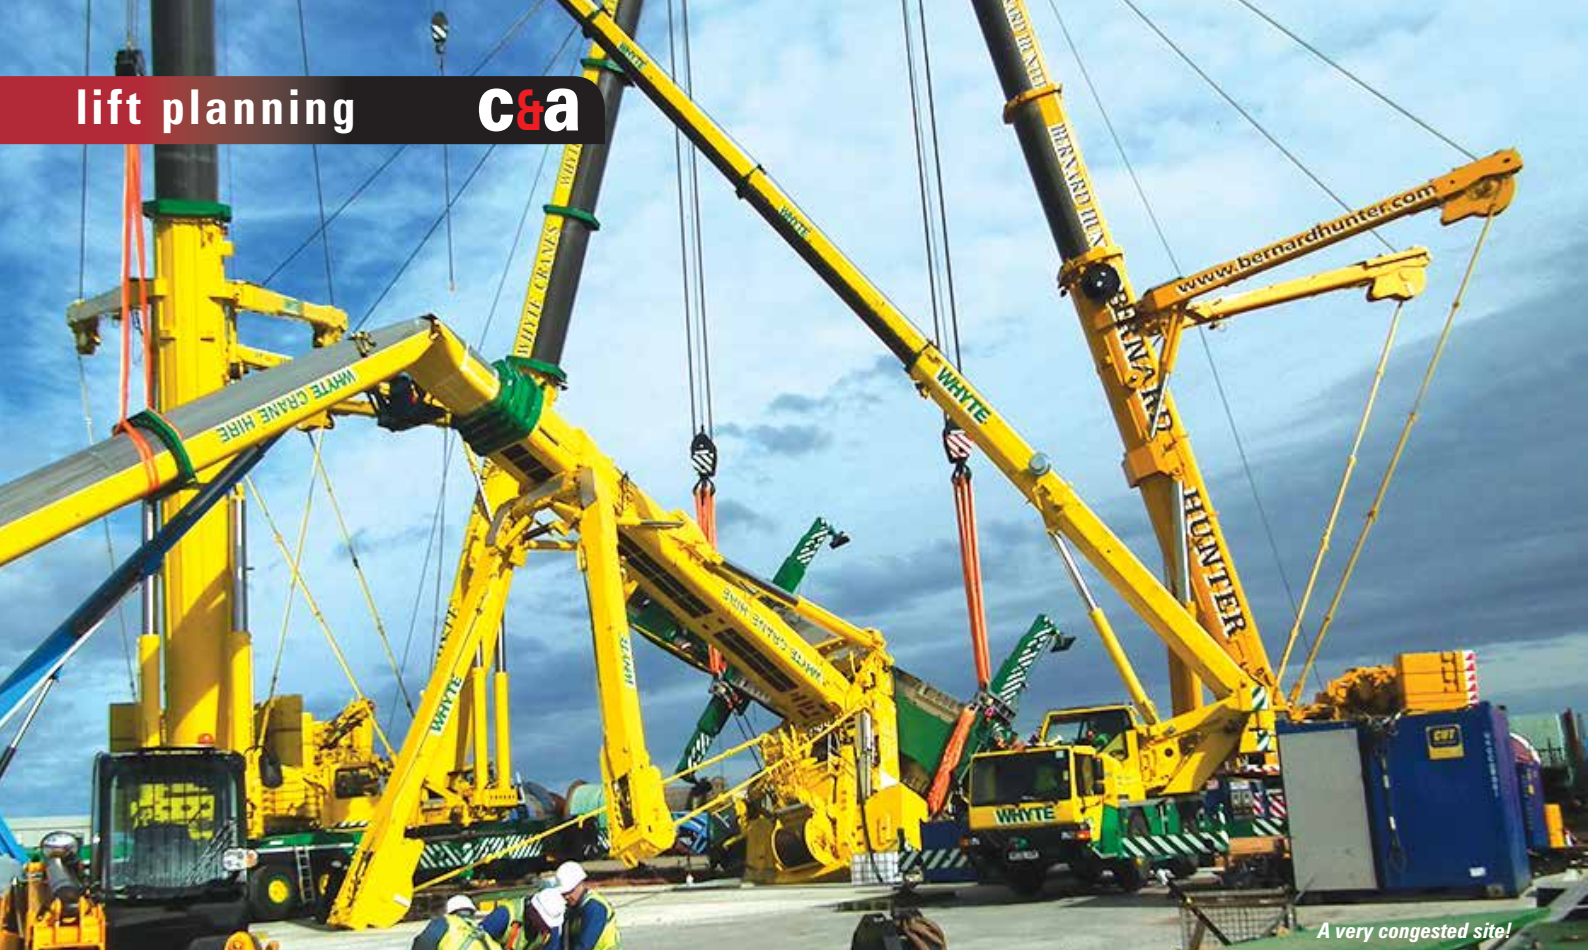
A very congested site!

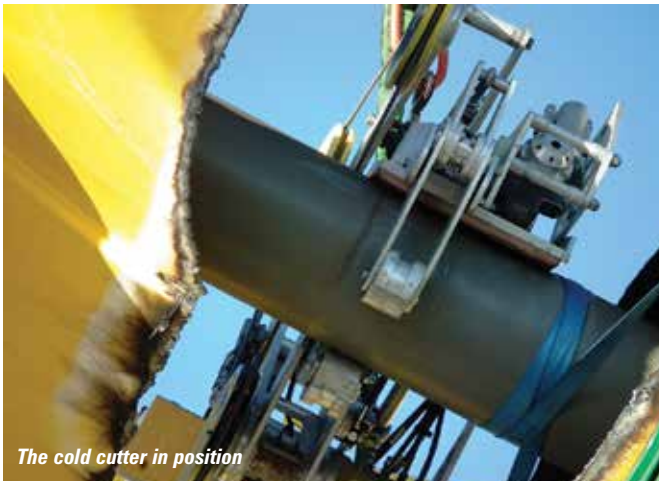
The cold cutter in position

Liebherr had insisted on the cold cut method because of the potential fire risk from 1,000 litres of hydraulic oil in the telescope cylinder. Although no-one had used the cold cutter before, it worked well. However before the cylinder could be cut, the oil had to be drained. The solution was to use a telehandler with a large plastic container on the forks, acting as a massive drip tray. This was raised up under the boom and caught all of the oil without spillage.

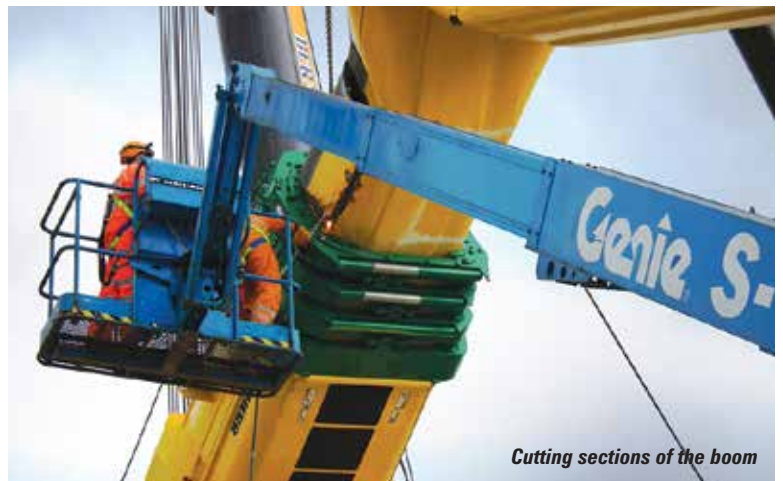
Cutting sections of the boom

(a 500 and a 100 tonner) while an opening was flame cut into section four to allow the team to see the telescope cylinder close to the point of failure. The hole was then enlarged in order to accommodate a hydraulic powered cold-cut saw - usually used for underwater cutting - and put into place by Issitt and Willis working from two 65ft Genie S65 boom lifts.

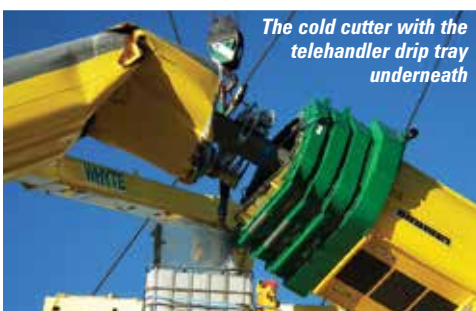
The cold cutter with the telehandler drip tray underneath

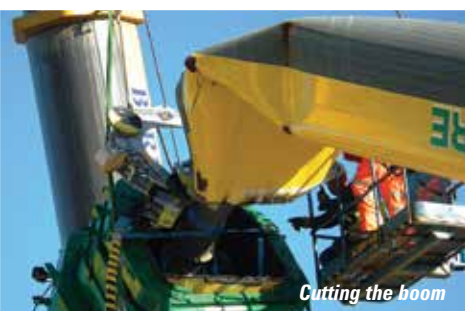
Cutting the boom

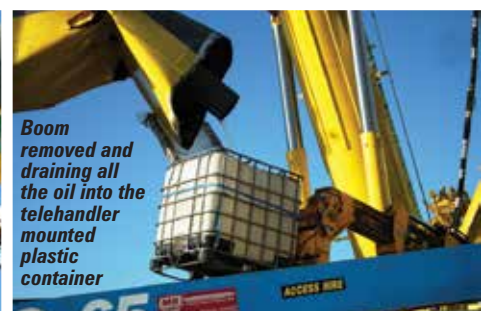
Boom removed and draining all the oil into the telehandler mounted plastic container

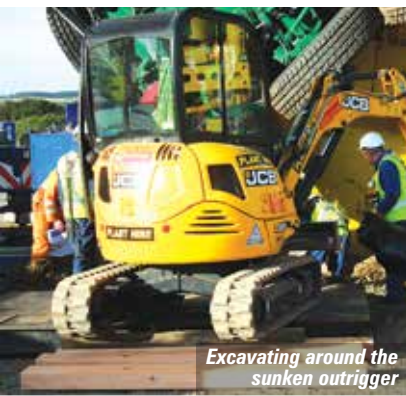
Excavating around the sunken outrigger

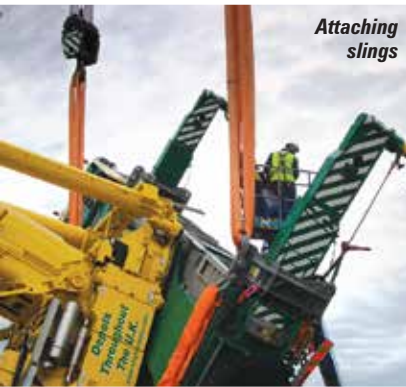
Attaching slings

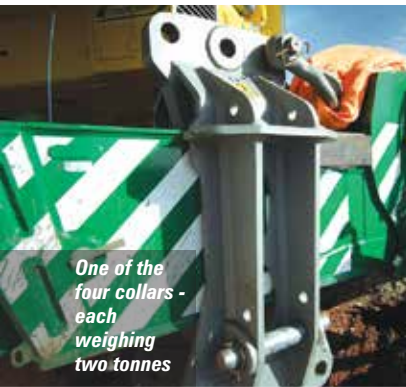
One of the four collars - each weighing two tonnes

To achieve the lift four special collars, each weighing two tonnes, were manufactured by Liebherr and fitted to the crane's four outrigger beams, close to the chassis. These were braced by two heavy chains underneath and one on top, each able to carry loads of 100 tonnes pulling through a sling.

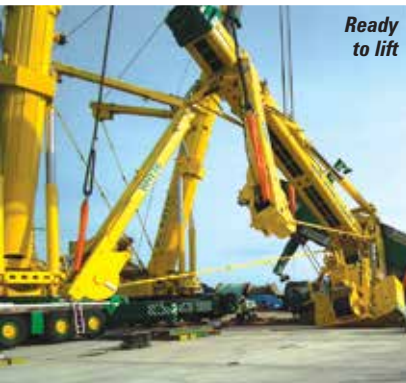
Ready to lift

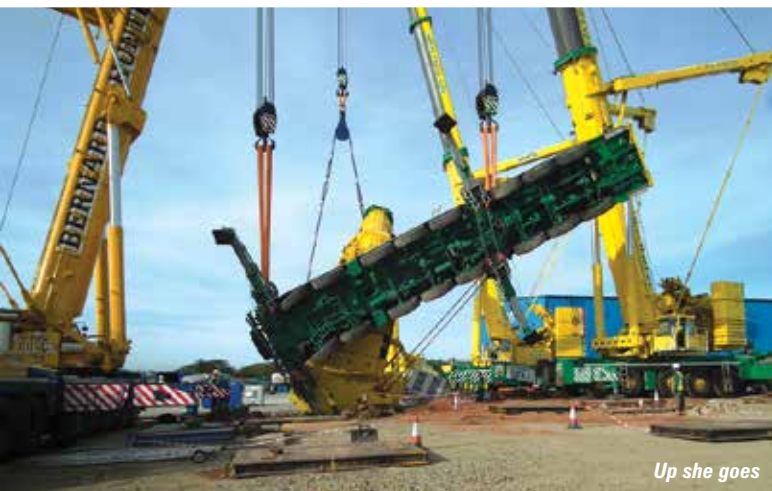
Up she goes

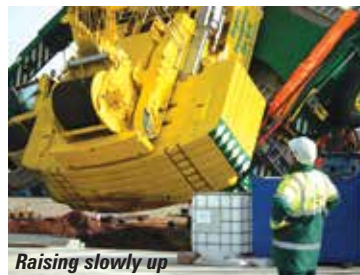
Raising slowly up

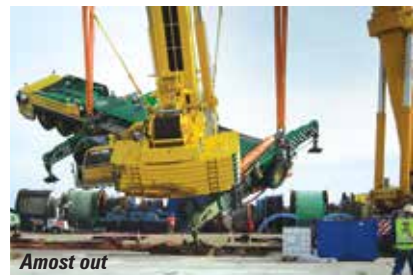
Almost out

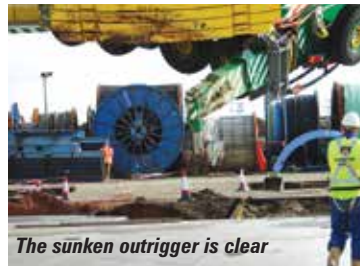
The sunken outrigger is clear

punched into the ground without collapsing.

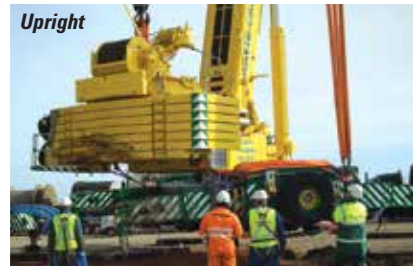
Upright

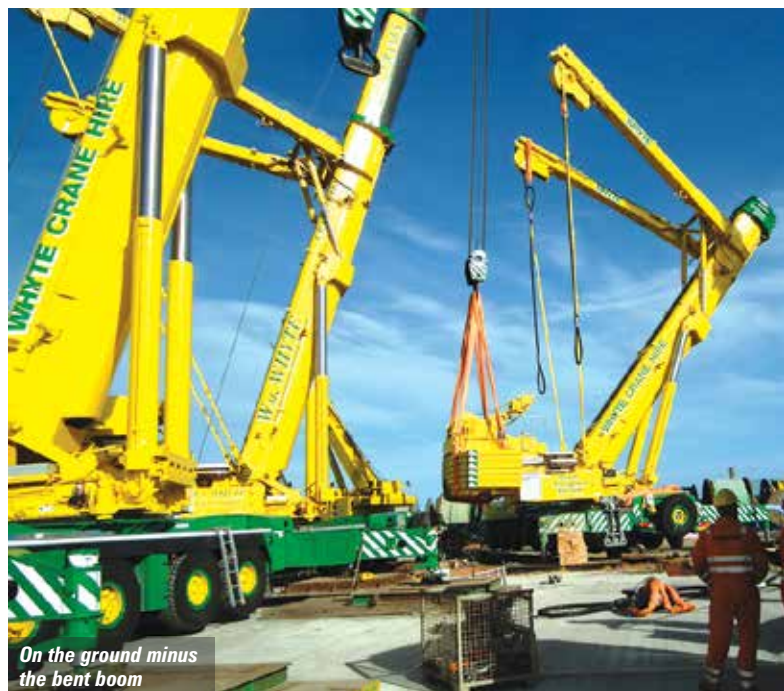
On the ground minus the bent boom

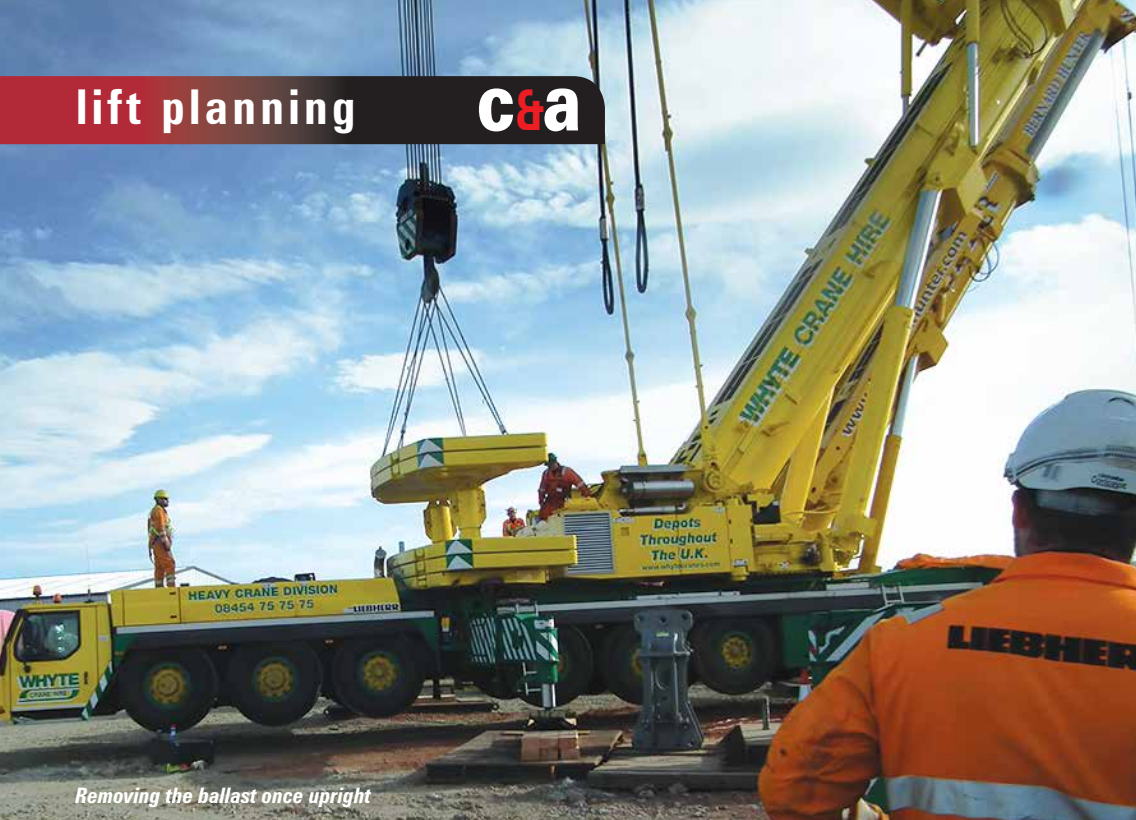
Removing the ballast once upright

"Once the crane was upright again we plumbed in our power pack, got the electrics working and the boom down, folded the 'Y-Guys' and removed the ballast. In fact there was very little damage to the crane and within two days, it was driven down to the Liebherr facility in Biggleswade, Bedfordshire. The main damage was the boom section which had been cut and some damage to the rear axle torsion bars that bent as it went over. It took a day to get the bottom engine running as oil had travelled up to the topside - typical in these cases - and a second day installing the new torsion bars - testament to the fact that the machine recovery went so well.

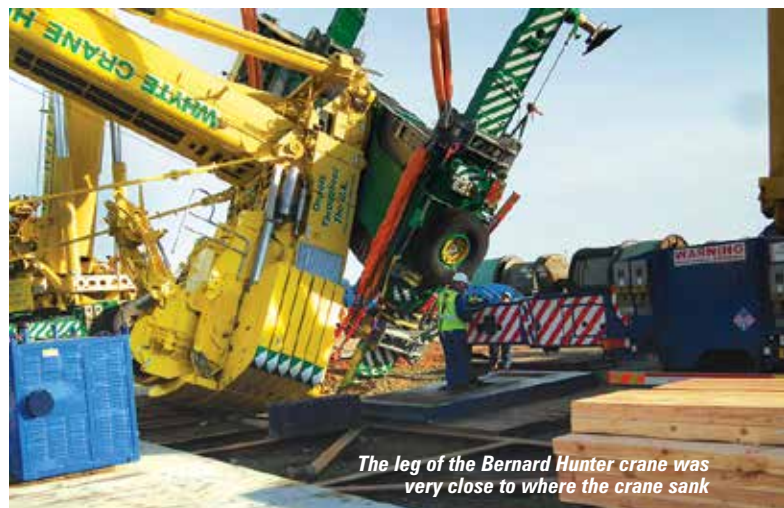
"The ground where the Bernard Hunter crane was set up was the worst so laser levels were installed on the outriggers to check for any movement while carrying out a test lift. We certainly didn't want another crane going over and one of its outriggers was precariously close to the area that had given way."

The leg of the Bernard Hunter crane was very close to where the crane sank
