Shock costs \$80,000

Scaffold tower fall

Overturned scissor

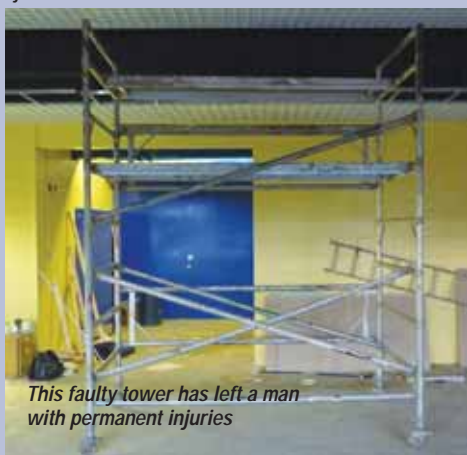
The investigation found the tower had been made up of parts from several different manufacturers, all of which were in a poor or damaged condition. HSE inspector Mark Baker said: "This man has suffered severe physical and mental injuries that will affect him for the rest of his life.

This faulty tower has left a man with permanent injuries

The scaffold tower the company provided simply wasn't up to the job and his life was put in danger the minute he started to climb it. This case should act as a warning to firms not to cut corners and to make sure they use the right equipment for the job they're doing."

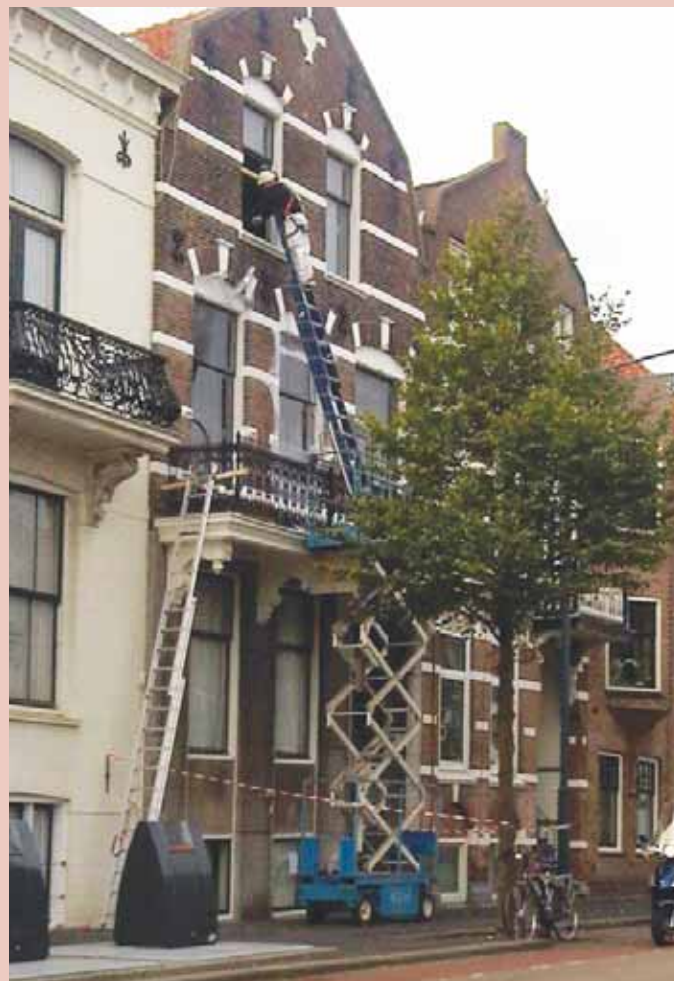
Who trained him then?

A man in Vlissingen, the Netherlands combines his ladder with a 20ft narrow aisle scissor to reach a window. When the photographer explained the risks of overturning the scissor by his make do methods he responded that he was being very careful!
