That sinking feeling!

Using some form of material or method to spread the weight of heavy objects, to stop them sinking into soft ground dates back to the earliest of times. The principal is all too obvious and yet hardly a week goes by that we do not receive reports of cranes and work platforms overturning due to being set up on soft or unsuitable ground without some method of spreading and supporting the load.

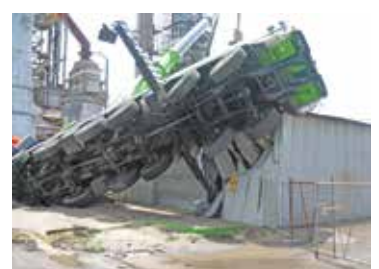
A soft verge takes another crane

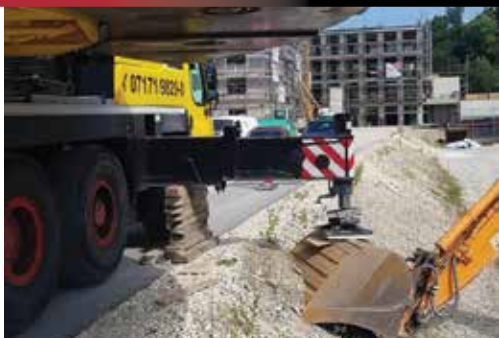
With insufficient space to set up, this All Terrain crane used the upturned bucket of an excavator. Not a recommended cribbing method!

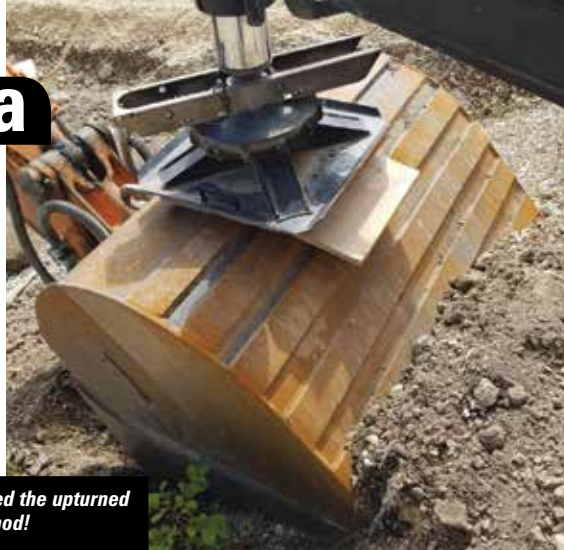
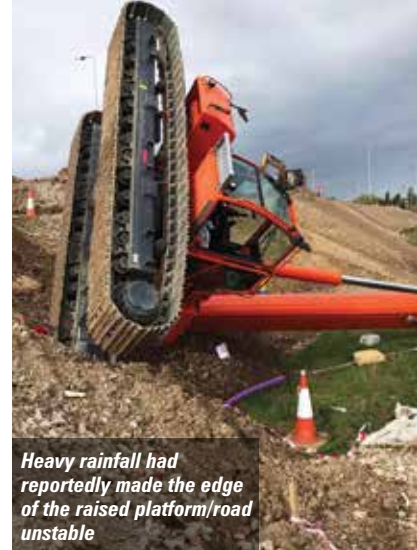
Heavy rainfall had reportedly made the edge of the raised platform/road unstable

An unusual but related incident occurred earlier this month when a telescopic crawler crane overturned alongside the M4 motorway near Slough in the UK. The 45 tonne Marchetti was working on a bridge widening project and was travelling on a prepared raised platform/road. However heavy rainfall had reportedly washed away much of the Type 1 material, reducing the platform's ability to support the crane and it gave way. The crane was travelling with its tracks in the retracked position and was guided by a spotter. The space available was less than generous, possibly forcing the crane to travel closer to the edge than was ideal, given the week or more of heavy rain.

As the incident highlights, even when a specific platform has been built for the job, its condition needs to be monitored, and possibly tested on a regular basis. The crane operator can play a part in this and ought to walk the route in advance, but to be fair, they are hardly likely to be an expert in the ground bearing ability of an 'engineered platform', although a highly experienced and

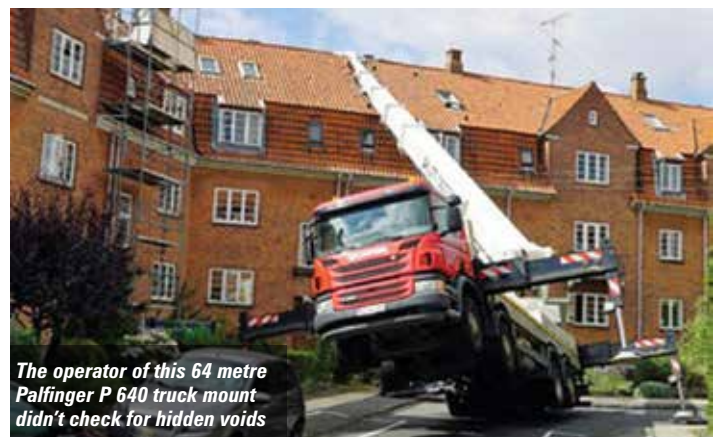
The operator of this 64 metre Palfinger P 640 truck mount didn't check for hidden voids

This was highlighted in another incident this month - this time in in Valmuevej, near Copenhagen - when a 64 metre Palfinger P 640 truck mount overturned onto the roof of a building. It seems was the rear load side outrigger punched through the pavement into a hidden void, causing the machine to lose stability. Outrigger mats had been used but they were hardly any larger than the machine's jack pads. Thankfully the boom and basket came to rest on the roof a substantial height above the ground on the back side of the building. The two men in the platform - the operator and a stone mason - managed to remain in the platform and were rescued by local fire and rescue service with the help of another platform.

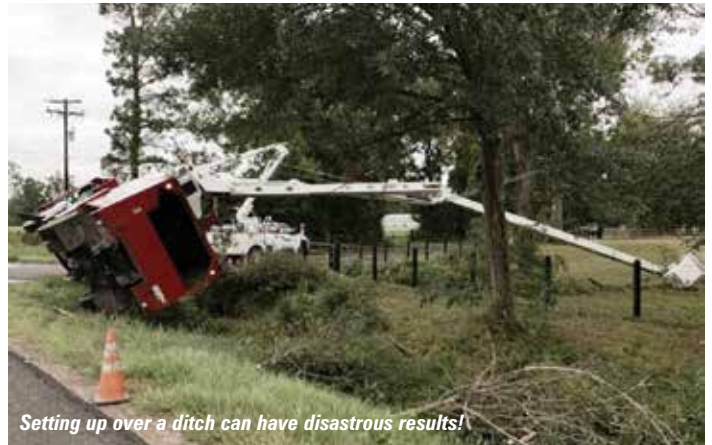
Setting up over a ditch can have disastrous results!

done when an operator is oblivious to potential dangers. The operator of a bucket truck working for the Sam Houston Electric Cooperative on a road north of Houston, Texas had set up alongside an open culvert in order to trim trees away from overhead power lines. The machine's stabilisers barely reached the ground, with one in the ditch, leaving the machine unstable when working over the side, particularly at

maximum outreach. Not surprisingly the lift overturned throwing the operator out of the platform as the lift's boom landed on the power lines cutting electricity to around 500 local residents. Thankfully he had a relatively soft landing and suffered relatively minor injuries. Improved training and awareness is surely the only way to prevent this sort of thing occurring?

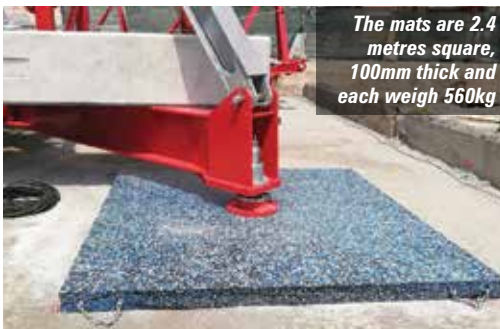
The mats are 2.4 metres square, 100mm thick and each weigh 560kg

A team from FM Gru visited Vertical Days this year to look for mats large enough to support its 2670 TLX and 2675 TLX flat top cranes. The team met UK-based Outriggerpads, which agreed to produce the 2.4 metre square, 100mm thick bespoke mats, each of which weighs 560kg. Made from high performance UHMW polyethylene, they are said to be more robust than metal or wood equivalents. Each mat has four integrated 'handles' for ease of lifting and handling.

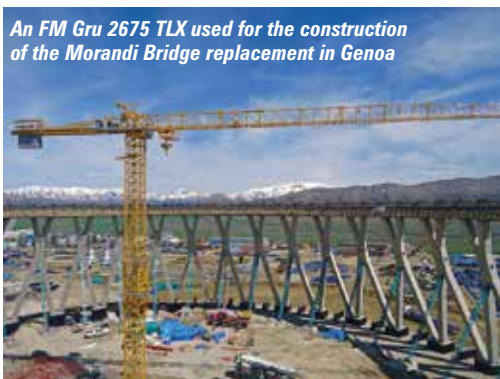
An FM Gru 2675 TLX used for the construction of the Morandi Bridge replacement in Genoa

Italian tower crane manufacturer FM Gru has purchased 16 bespoke crane mats to support four of its cranes during the construction of the Morandi Bridge replacement in Genoa, Italy.

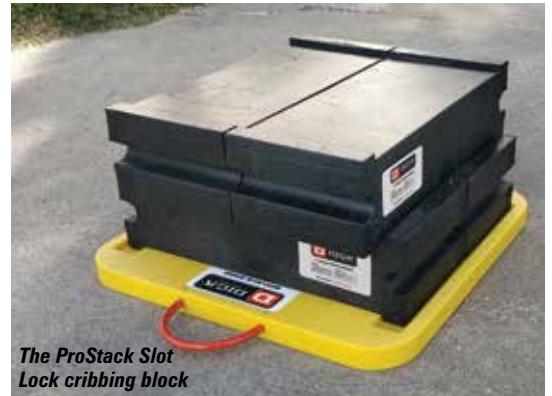
The ProStack Slot Lock cribbing block

US-based DICA has launched the ProStack Slot Lock cribbing block. The blocks are designed to stack and lock together to safely increase cribbing heights. They are made from a combination of recycled material and additives to produce what the company describes as a strong, reliable, and environmentally friendly solution

A SafetyTech base pad and two ProStack block set up has a 454kg/35bar load bearing capacity. Each layer increases cribbing height by 127mm, and the surface allows room for outrigger jack pads of up to 450 x 450mm. The blocks weigh 13.6kg, and include moulded grips make them easier to carry. TuffGrip handles can be added to facilitate carrying two blocks at once. They are guaranteed for 25 years against rot, insect infestation, splitting, cracking or splintering.

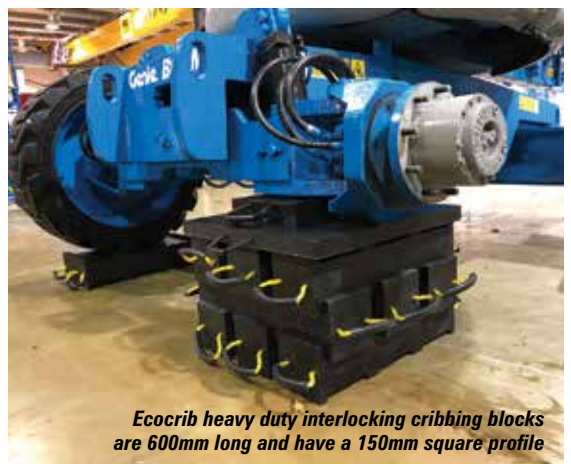
Ecocrib heavy duty interlocking cribbing blocks are 600mm long and have a 150mm square profile

UK based Outriggerpads has launched a new range of composite cribbing and jacking blocks. Manufactured from heavy duty polyethylene, the new range of Ecocrib heavy duty interlocking cribbing blocks can be used anywhere traditional wood cribbing is used, however they have the benefit of firmly interlocking with each other and do not corrode or splinter, while being resistant to water.

They can either be used in two blocks per layer for lighter or less concentrated loading, or three blocks per layer for heavier loadbearing applications. The 600mm long and 150mm square profile blocks are tested for loads of up to 100 tonnes. Each block has two integrated rope handles for ease of lifting and stacking. The stack can be topped by one of three 600mm square top mats, with weights of 20kg, 25kg and 30kg.
