More mats

c&a outriggers

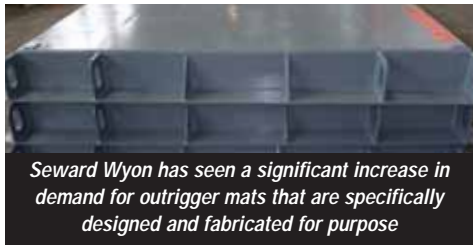
Seward Wyon has seen a significant increase in demand for outrigger mats that are specifically designed and fabricated for purpose

We were contacted by Seward Wyon the crane and equipment fabricators, which has seen a strong uptake in demand for its range of fabricated steel mats for cranes to meet customer demand for a rigid mat that was not too heavy, for both handling and travel weight reasons. The company is also increasingly designing and fabricating mats to specific requirements, using the correct grade of steel and a calculated design to provide specific outrigger load distributions.

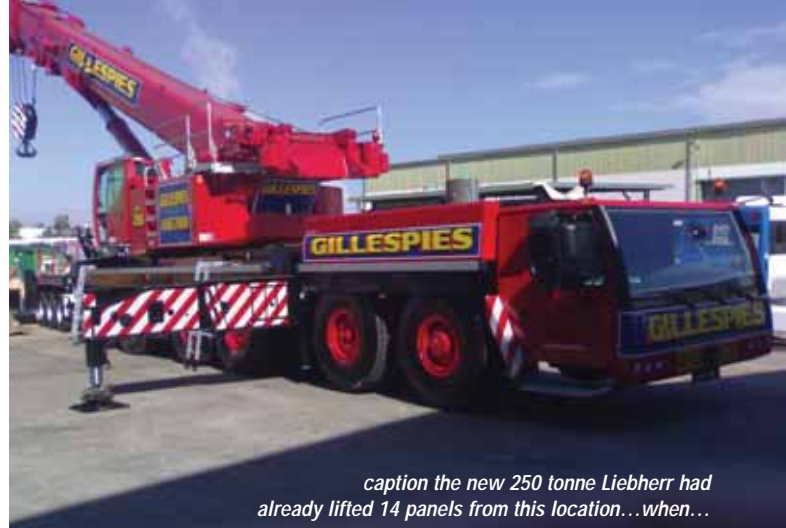
caption the new 250 tonne Liebherr had already lifted 14 panels from this location...when...

Having successfully carried out a number of lifts from two different locations over a three day period the new crane moved to position number nine and set up exactly as before, with no outrigger mats or cribbing as per the contractor's engineers explicit instructions.

(It was clearly important that all loads were transferred through the concrete to the supports and not spread over the floor). Once the crane was set up in the new position by the three man crew, the subcontractor and main contractor both signed-off on confirmation that it was in precisely the correct position over the painted crosses and free to start lifting.

Fourteen panels

were lifted and placed according to plan but when the 15th was lifted the crane telescoped the load out and one of the outriggers suddenly broke through the slab, causing the boom to come down onto one of the erected panels where it came to rest.

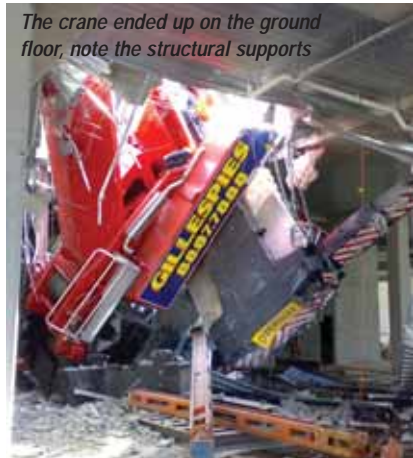
The crane ended up on the ground floor, note the structural supports

The crane remained in that position for around an hour before the entire slab gave way dumping the crane six metres to the ground floor below.

There were at least six men working on the ground floor when the outrigger first punched through and at that time all of the structural supports were reported as still standing upright. It seems that one of the supports was not correctly positioned. While this seems obvious, it has not categorically been confirmed as the case. Photos taken on mobile phones before the crane crashed through the floor are not clear enough to confirm it.

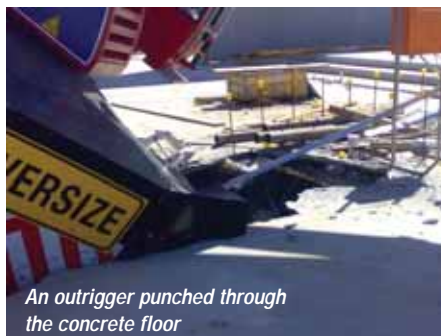
An outrigger punched through the concrete floor

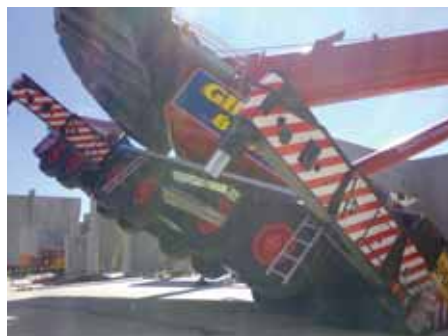
The crane tipped and the boom came to rest on a panel

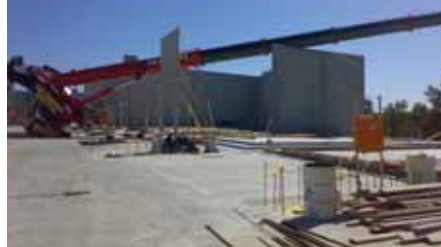
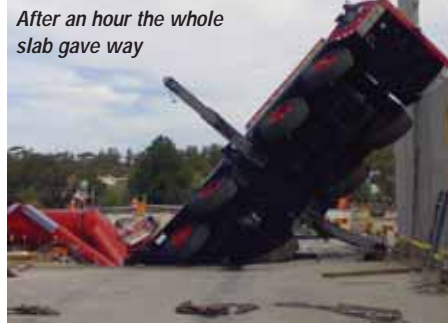
After an hour the whole slab gave way

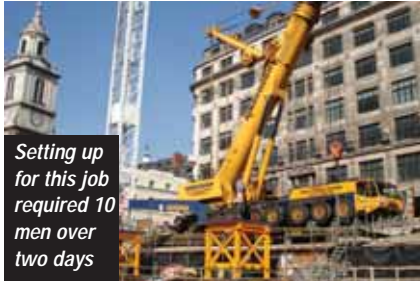
Setting up for this job required 10 men over two days

plan to utilise an 800 tonne capacity Demag AC2000 All Terrain crane, with the outriggers on one side sitting over a utility tunnel while the other two outriggers would need to sit on special structures to cope with a four metre drop to the base of the excavated site.

With Houndsditch temporarily closed to vehicles, but open to pedestrians, the entire area of the road and nearside footpath was covered in a 100mm thick sand/cement dry mix, over which a double layer of Trax heavy duty aluminium roadway panels was laid. Below each roadside outrigger five 7.5 metre x 2.2 metre steel mats were positioned, bridged by an 11 metre x three metre steel mat sitting on Ethafoam pads, to give an effective bearing area of 97 square metres. This arrangement brought the bearing pressure on the road surface down to 1.65 tonnes per square metre, which proved acceptable to the authorities.

The height of this multiple arrangement of load spreading mats meant the wheels of the crane had to be at least 750mm above the original road level in order for the outrigger legs to swing out into their working positions. This was achieved by reversing the crane up a temporary ramp onto a raised pad constructed from timber crane mats.

Installing the complex configuration of mats and road protection and the crane itself took 10 men a total of two days, with 10 truckloads of equipment being required. The AC2000 was configured with a 55.5 metre main boom equipped with Sideways super lift and 160 tonnes of counterweight, allowing it to lift the 40 tonne steel columns at the required radii up to 40 metres.

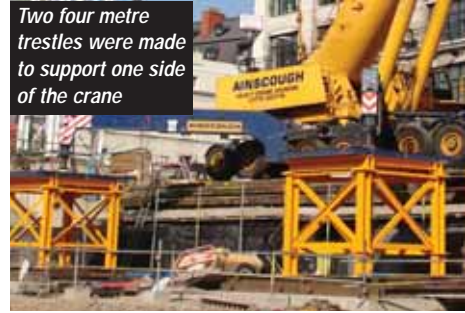
Two four metre trestles were made to support one side of the crane

On the other side where the outriggers were swung out over the excavations, Severfield Reeve designed and fabricated two four metre high structural steel trestles, these sat on two purpose built concrete pads covered with heavy steel outrigger mats. Ainscough's normal steel outrigger mats were fitted to the top of the trestles thus providing a stable base to support the crane.
