# ARE WE LEARNING ANYTHING FROM FAILURES?

Over the past year or so, mastclimbers and hoists have been in the news for all the wrong reasons. Seven people have died in just two incidents - five in Sweden and two in the UK - yet the difference in the way the safety authorities have dealt with them could not be more different. C&A takes a look at both.

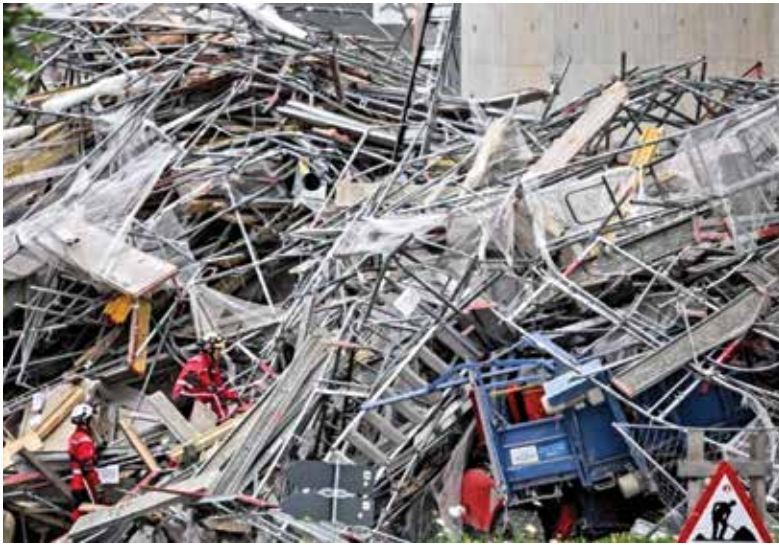
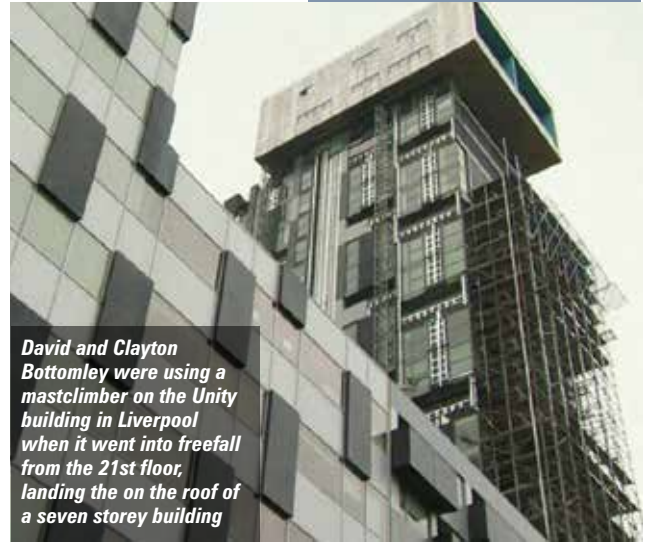
*David and Clayton Bottomley were using a mastclimber on the Unity building in Liverpool when it went into freefall from the 21st floor, landing on the roof of a seven storey building*

Almost a year later in September 2024 the inquest actually got underway. HSE inspector Andrew Crouch confirmed the investigation had found that a small pinion shaft in the gearbox - which sits between the drive motor and brake and the main drive pinion - had fractured and failed on

both drive motor assemblies leaving the platform without any drive or brakes leading to the freefall.

Crouch added that the shafts must have failed at different times, indicating that the unit continued to be used after one of the drive motors and brakes had broken. He added that it was impossible to say when the first shaft had failed, and therefore how long the platform had been operated with a single drive motor and brake. As to the cause of the failure he said that an HSE metallurgist had simply determined that it was due to 'metal fatigue'.

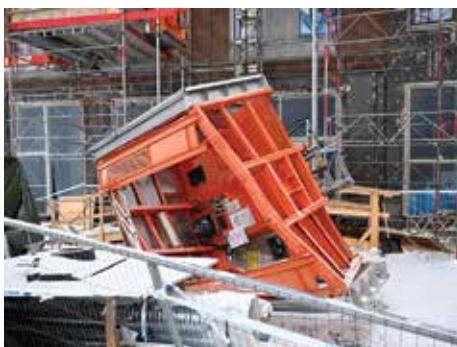
Five occupants in this hoist car died when it crashed to ground from a height of around 20 metres

The Alimak Scando 650 hoist was attached to the building being built by local contractor and developer Andersson Company. It initially appeared that the mast had given way or became detached, causing the mast and hoist car to crash to the ground from a height of around 20 metres killing all five occupants.

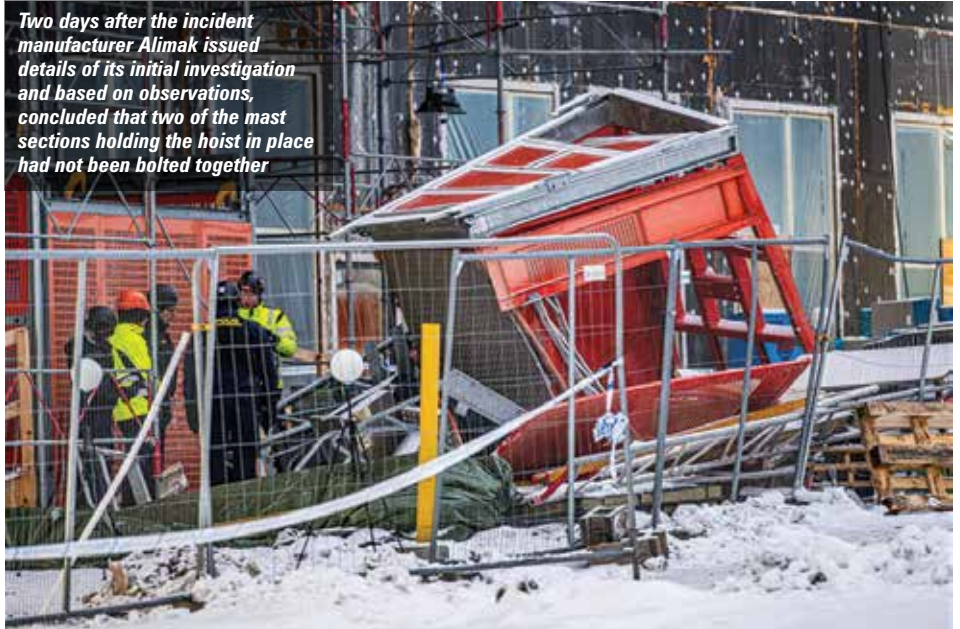
Two days after the incident manufacturer Alimak issued details of its initial investigation and based on observations, concluded that two of the mast sections holding the hoist in place had not been bolted together

The investigation report said: "The accident occurred when the load on the mast where the four bolts and nut assemblies were missing became greater than the structure could hold, leading to the mast sections separating and the hoist car falling to the ground. It is likely that the bolts were already missing from the three-section mast extension when it was added at the start of November. However, this was not spotted when installed, nor in the subsequent inspections and service measures taken after the assembly. The accident was caused by failure to perform relevant safety inspections on the mast and thus not picking up the missing bolts."

The installation guide/manual with drawings clearly warns of the risks of leaving any bolts out. And yet it is clear that five bolts were missing at the time of the accident - one between sections 19 and 20 and all four bolts between sections 18 and 19, meaning that the sections above that were only held in place by the friction between the short spigots and the sockets of the section below.

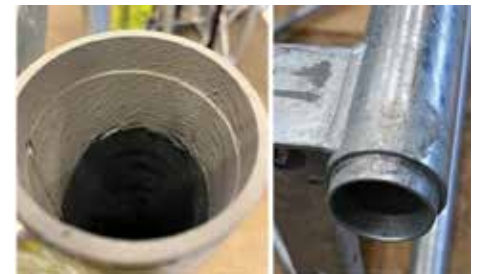
With critical bolts missing, the mast sections were only held in place by the friction between the short spigots and the sockets of the section below

The offending sections were installed on the 1st of November with the joint in question being the one between the middle and lower section in a run of three that were preassembled and installed by crane. It has not been determined if the bolts were missing when the 4.5 metre length was delivered to site some weeks earlier, or if the bolts had been removed on site for some reason. Regardless, the subsequent inspections failed to spot that they were missing.

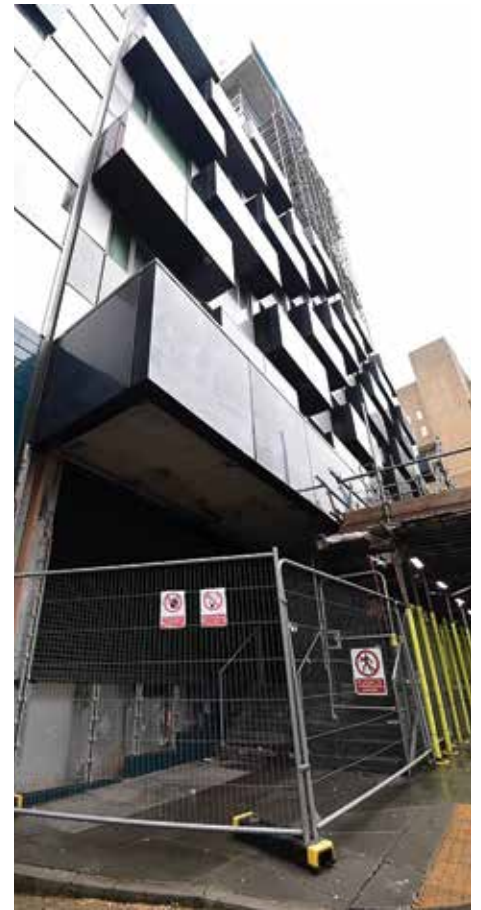
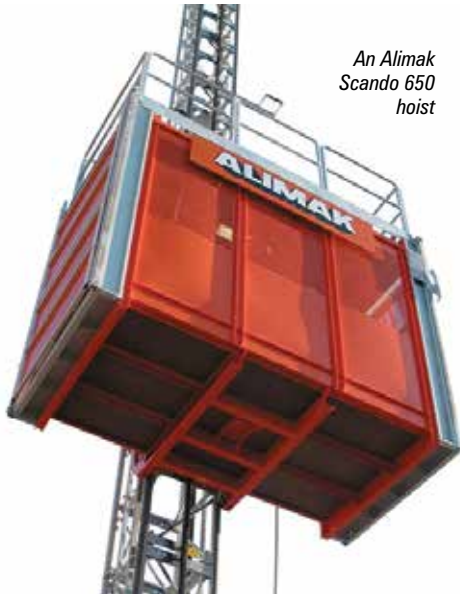
*An Alimak Scando 650 hoist*

The Scando 650 - serial number 816849 and manufactured in 2016 - has 1.5 metre long mast sections each weighing 115kg. The sections are connected with short spigots on each of the four corner tubes, with four large bolts - one near each corner - and lock nuts to hold the sections firmly together. They are installed from below, with the

nuts on top, so that they cannot be left off as the bolts would simply drop out. Also, if by chance a nut vibrates loose, or the bolt should shear they drop out.

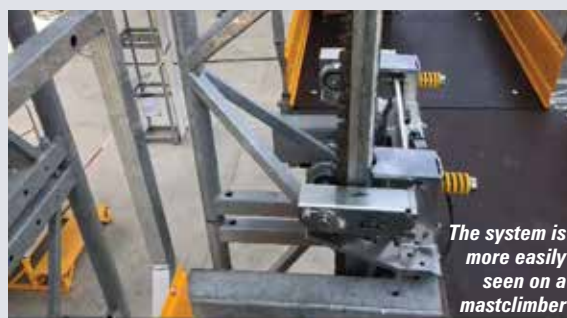
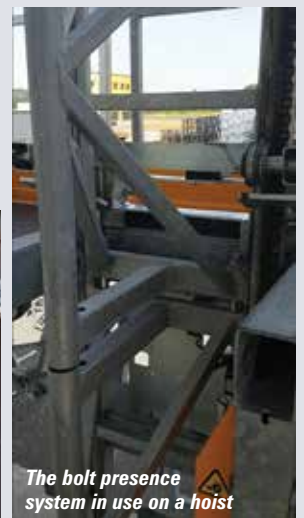
## ELECTROELSA 'BOLT PRESENCE'

**One company that already has a system that detects missing, or even loose mast bolts is Italian hoist and mastclimber manufacturer Electroelsa. Introduced and patented in 2021 it is now installed as standard on all of its models.**

During the mast assembly the installer places the 'Bolt Presence' system on top of the mastclimber or hoist and around one side of the mast. The system then applies pressure on the mast section it is in contact with and monitors any unexpected movements, such as when the mast sections are not correctly bolted together or adequately torqued. If it does, the power is automatically cut and the brake applied stopping the platform from climbing any further. The operator must then manually override the brake to restore the power to lower the platform and insert or tighten the bolt. Once the mast section is correctly bolted together, the hoist or mastclimber can continue its movement up the mast.

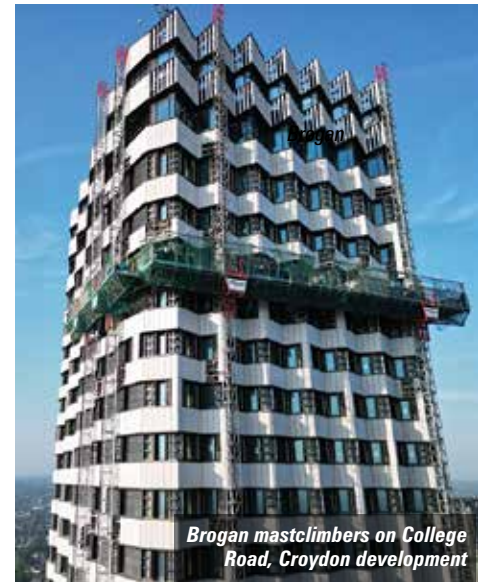
Brogan mastclimbers on College Road, Croydon development

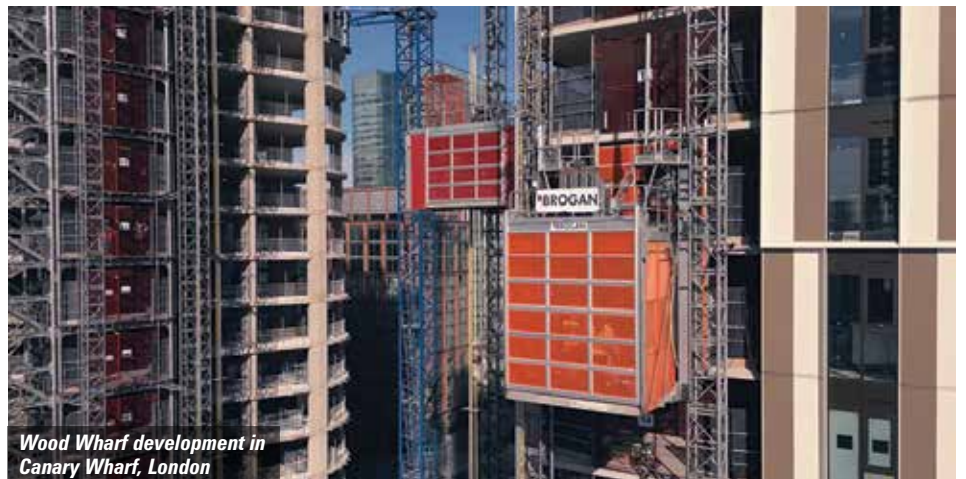
Wood Wharf development in Canary Wharf, London

Canada Water,  
London

The common tower solution has quickly become an attractive proposition for developers looking to build taller buildings more efficiently. The standard five by five metre four-sided tower is erected next to the building façade with the inside face connected to the building at each required floor by a three metre opening. The tower can support up to six large construction hoists on the remaining three free sides - two hoists per side - all of which feed into the tower and the single entry into the building.

Floors of the tower can support 4,000kg per square metre, and heights in excess of 250

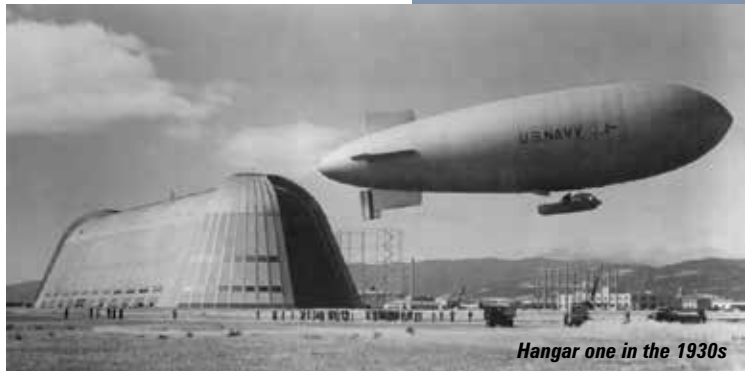
Hangar one in the 1930s

The structure is currently undergoing a massive restoration project headed by Google and NASA that includes removing and renovating parts of the steel structure and installing new cladding. It is hoped that this will preserve its historical value but also re-establish it as a hub for innovation.

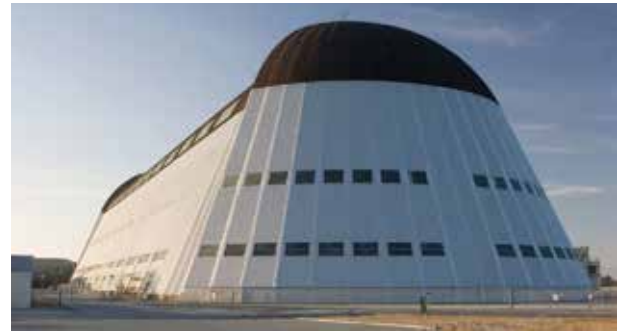
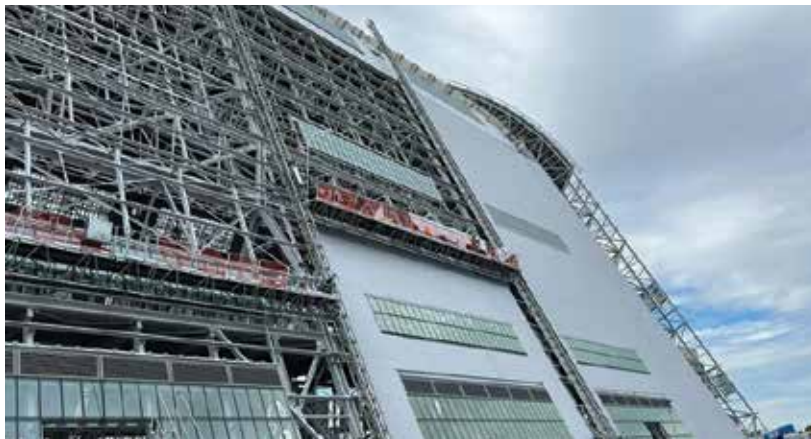
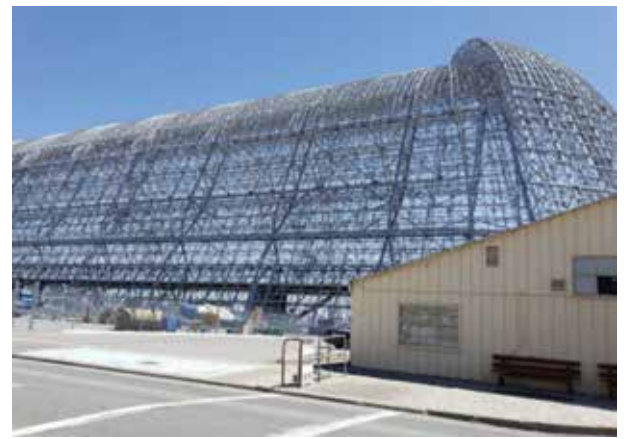
To carry out the external cladding work a custom twin deck, triple mast P45 mastclimber from SAEclimber was chosen featuring two independent drive units on one mast, while a material hoist at one end is also being used.

The mastclimber is 65 metres high and inclined at angles of 25 and 30 degrees. In order to keep the platform level, special drive units with levelling mechanisms are employed. A crucial aspect of the P45 was the anchor forces on the inclined façade and the metal structure's function, form and construction which required special attention including a tie solution specifically for the job and a new method of cladding placement.
