# £27K FOR SCAFFOLD TOWER OVERTURN

# OVERTURN COSTS CRANE OPERATOR A\$24K

# FATAL SCISSOR LIFT FALL

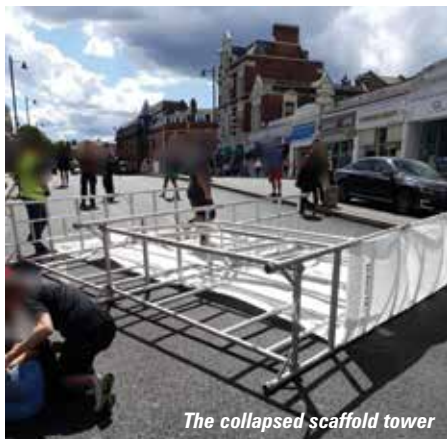
UK construction company Add Prop has been fined £20,000 plus costs of £7,000 after a scaffold tower overturned and landed on two pedestrians in southwest London. The tower, which was under the supervision of the company's sole director, Atif Riaz, was incorrectly assembled, had not been inspected by a competent person, and was not adequately separated from the public. It was then covered in sheeting which acted as a wind sail, causing it to overturn and land on two members of the public, resulting in serious injuries.

The HSE found that Riaz had been negligent as a director and project manager despite knowing the risks of wind loading on scaffold structures.

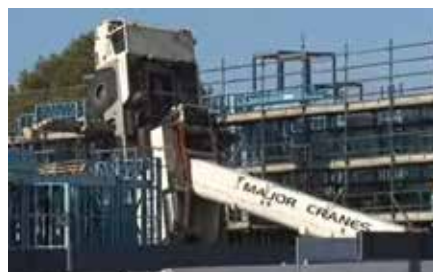
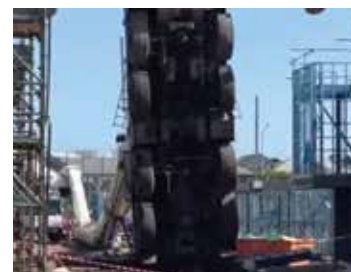
A crane operator, 38, has been fined A\$20,000 plus A\$4,000 in costs after his 200 tonne five axle All Terrain crane overturned onto a 70 tonne crane at a site in Williamstown North, Melbourne, Australia in 2023.

The crane's boom was fully extended over the rear at the time, while the operator was packing up for the day, but for some reason, rather than retract the full boom first, he lowered it to the point where the crane lost stability and overturned, with the boom landing on the counterweight of a 70 tonne crane almost 60 metres away. Fortunately, no one was hurt in the incident, although the operator needed help to exit the cab.

The investigation found that the crane, a Terex Demag from Major Cranes, overturned because its load limiter override switch was activated, allowing the boom to be lowered beyond its capacity. The investigation also found that the crane had been overloaded several times that day when those working below were too close to moving loads.

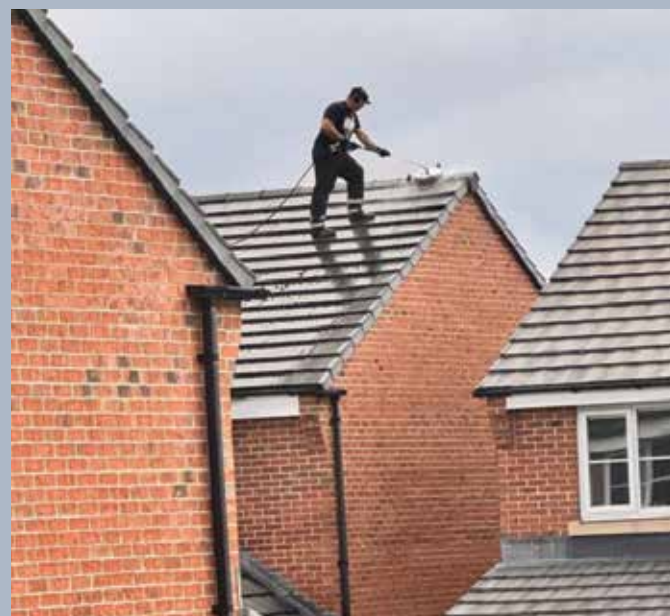
# WHO TRAINED HIM THEN?

Spotted recently by a reader from Manchester, UK, a man pressure washing the pitched roof of a house. In the reader's own words: "I am watching a man jet wash a roof with no fall protection from my home office window. I can't fathom the logic in risking your life for what I imagine is about £25 for a harness and lanyard."

Pressure washing moss and other growth from roofs is a rapidly growing industry in the UK, and thankfully, it employs a wide range of aerial work platforms, but many practitioners resort to tactics like this. But it has to be said that in most examples we have seen, some form of fall protection is used - steep slopes and water rarely mix, no matter how grippy your boots are.
